Introduction

Case Study 1: Goldstream Road

Case Study 2: Martin's Property

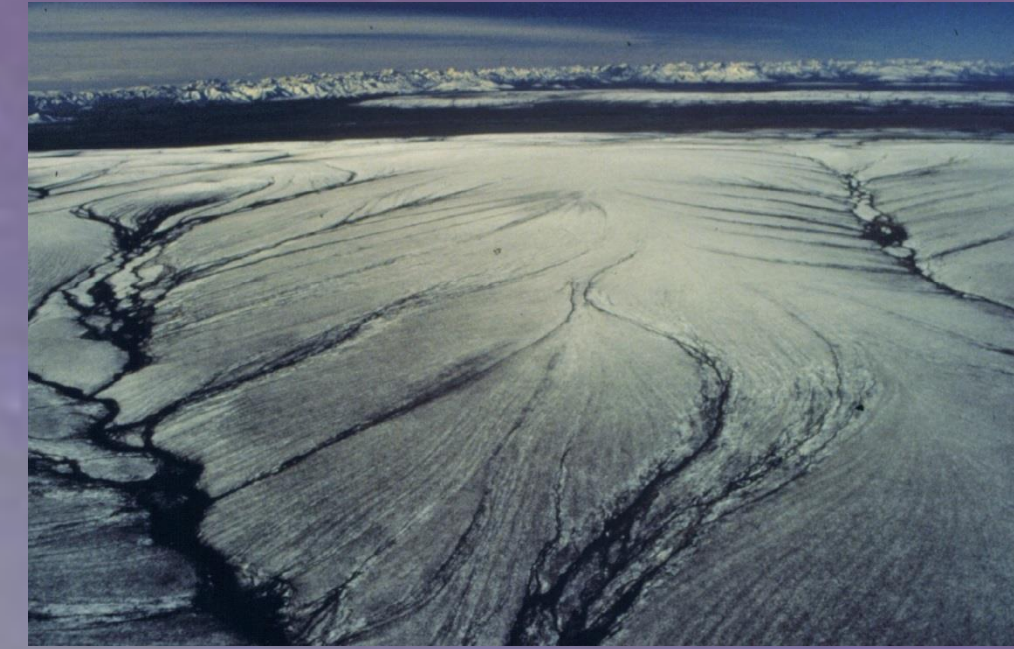
Figure 1: Water Tracks in arctic tundra. Photo Courtesy of Frontier Scientist

When there is a **constraining subsurface boundary** such as permafrost, clay, and bedrock, surface runoff and near-surface seepage form immature channel networks, known as “**water tracks**,” through the soil. Due to the extensive presence of **permafrost** in polar environments, water tracks (Figure 1) are the **dominant drainage pathways** and thus impose significant control on arctic and subarctic hydrology (Levy et al., 2011).

Existing literature on water tracks is limited and is largely confined to tundra areas (Figure 1) devoid of vegetation. Nonetheless, water tracks are still observed in subarctic boreal regions.

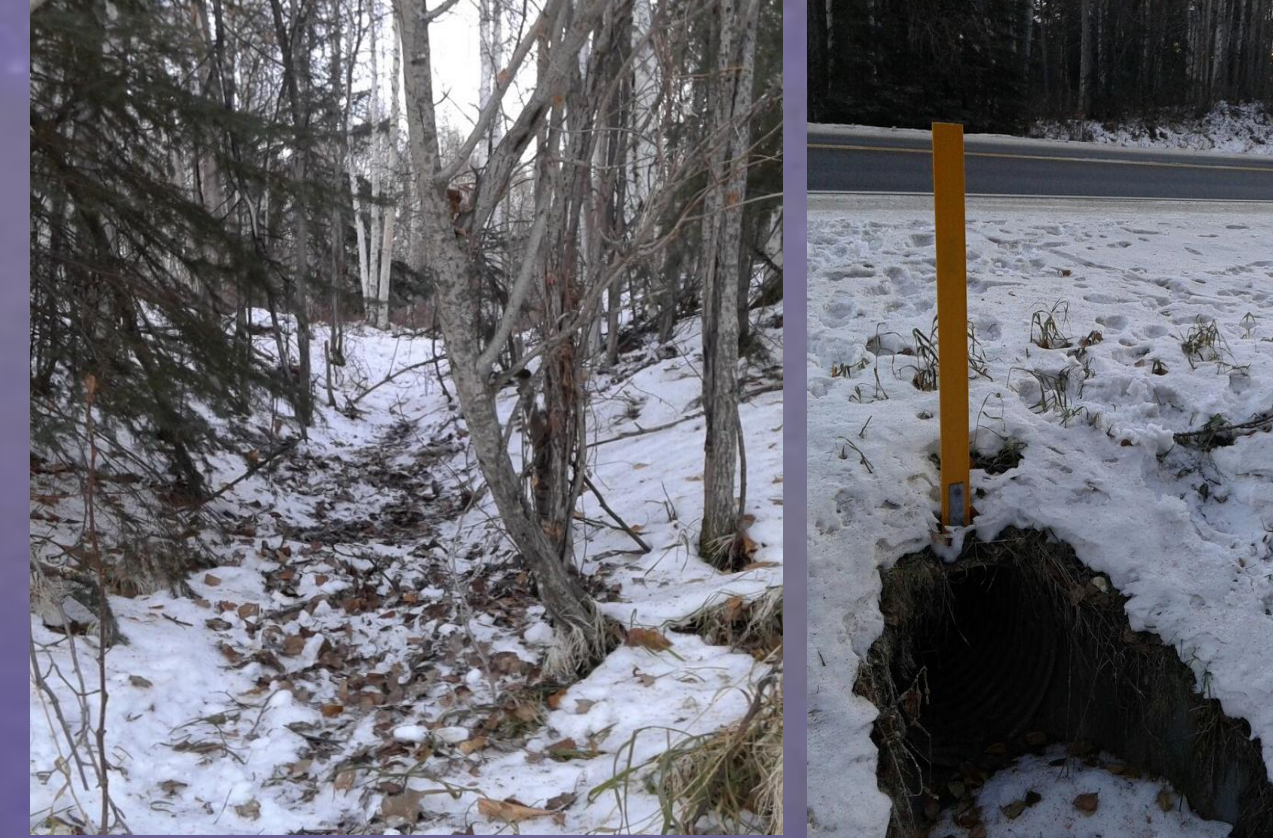
Figure 3: A prominent track intercepting the road

The Goldstream Road (Figure 2) in Fairbanks, Alaska experiences high amounts of damage, possibly due to prominent water tracks (Figure 3) that intercept with the road.

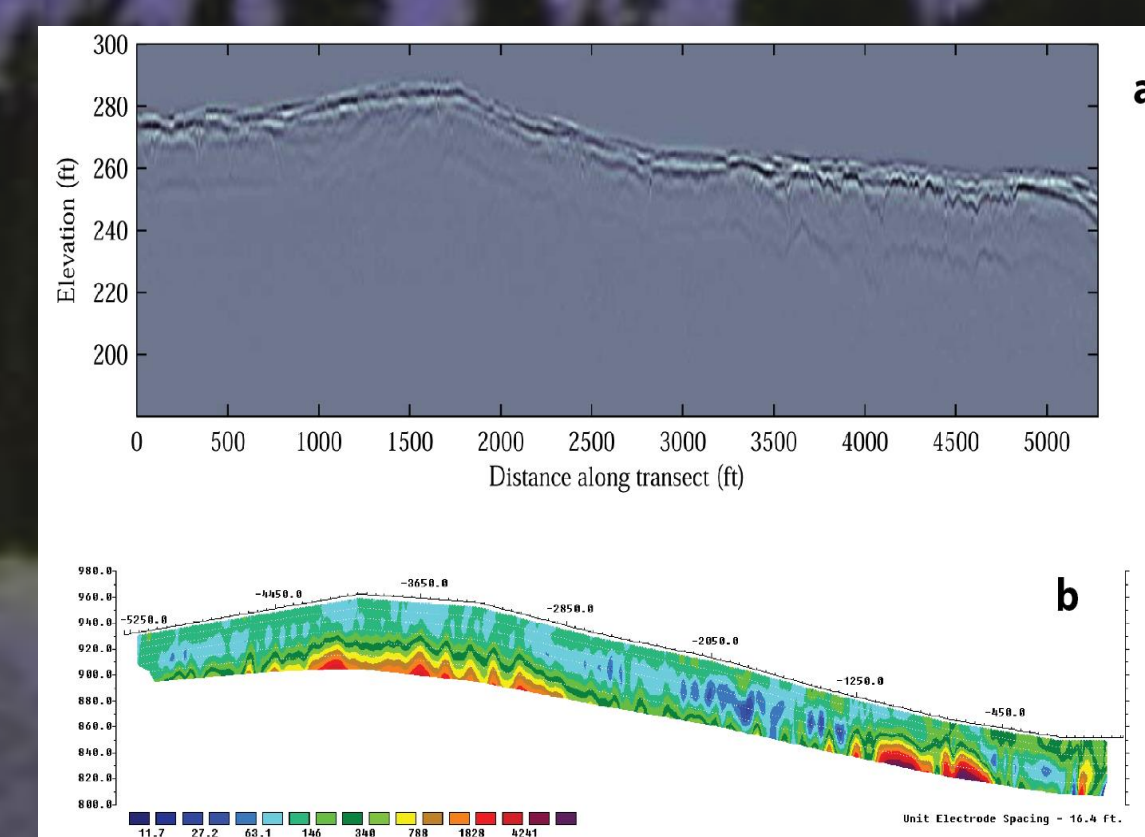
Figure 4: Goldstream Road geophysical results, MP 6-7 (Schnabel et al., 2014). a) Topographically corrected GPR survey collected March 2011 b) CCR-ERT transect collected spring 2012 (courtesy of CRREL)

In 2012, the Alaska Department of Transportation (AKDOT) in conjunction with the U.S. Army Cold Region Research Engineering Laboratory (CRREL) conducted a geophysical study on the Goldstream Road. The data from the geophysical study has been released for this study. See Figure 4 for sample data.

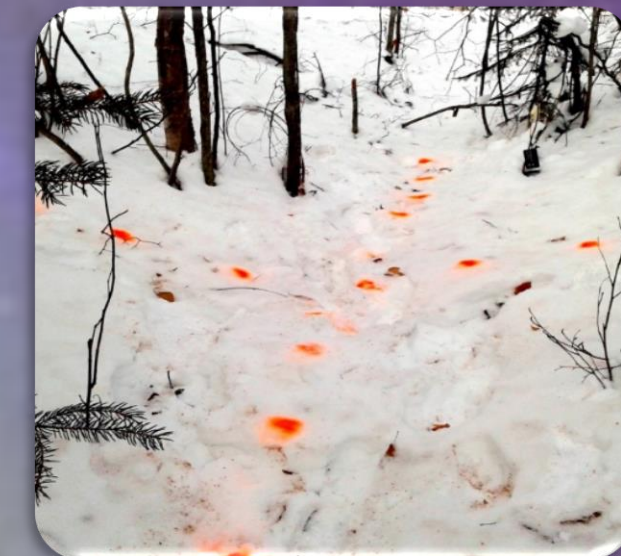
Figure 5: Set of transect lines

Each set of measurement was taken along two transects: **vertical** (along the water track) and **horizontal** (across the track). See Figure 5.

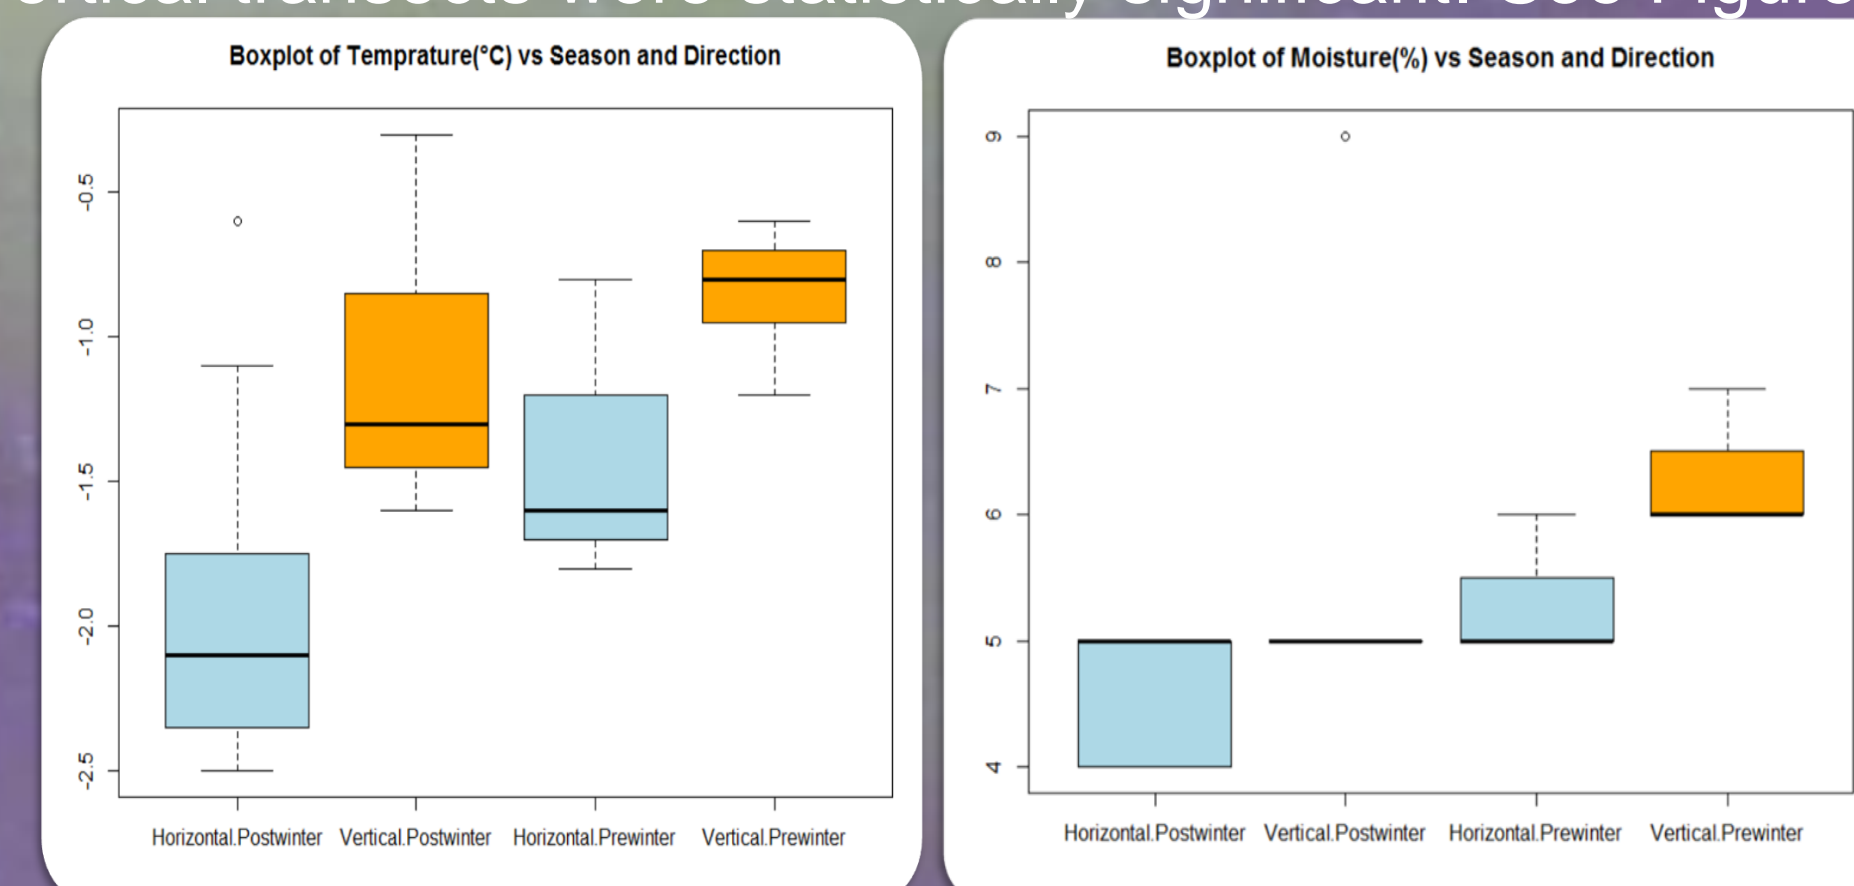
Figure 6: Boxplots of soil temperature and soil moisture along and across water track.

Statistical P test was performed on the acquired data. Differences in moisture content and temperature between the horizontal and vertical transects were statistically significant. See Figure 6 below.

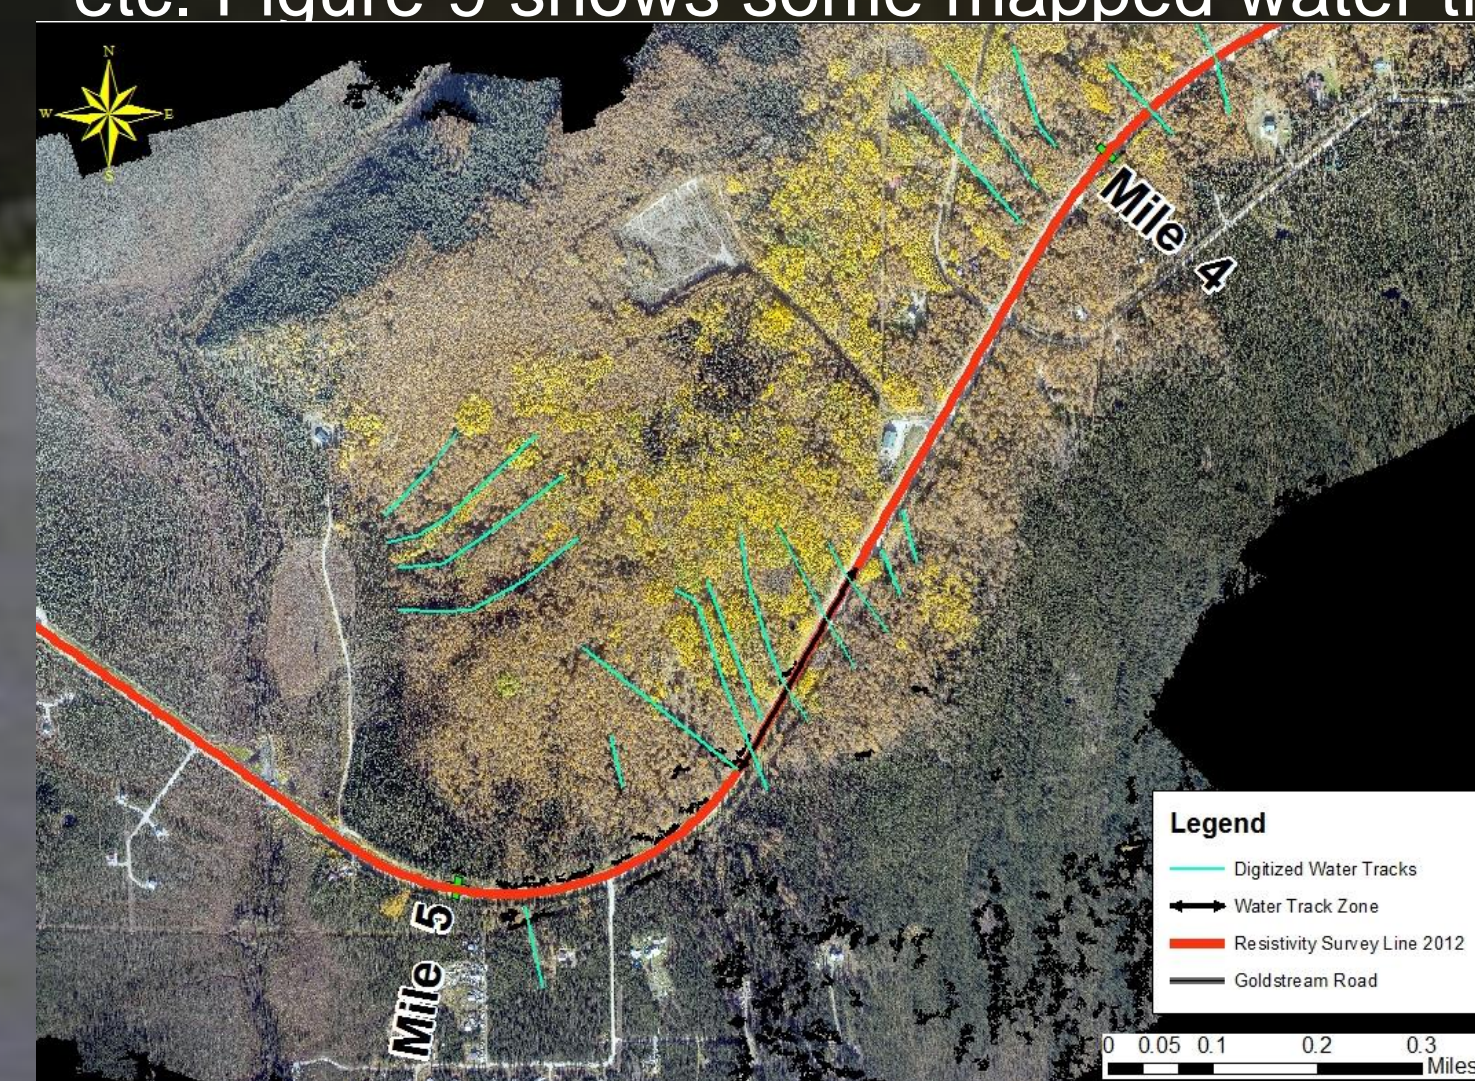
Figure 9: Digitized water tracks near Mile 4 and 5 on Goldstream Road. Basemap is orthophoto acquired by Dr. Matt Nolan. Note that vegetation changes between coniferous and deciduous.

- ❖ High spatial-resolution DEM (57 cm x 57 cm) and orthophoto (14 cm x 14 cm) were acquired by Dr. Matt Nolan in September 2014. Using the acquired images and other Web Map Services (WMS), linear and curvilinear features were manually digitized and were stored in a water track geodatabase, with relevant attributes such as width, vegetation on/off track, interception with infrastructure, etc. Figure 9 shows some mapped water tracks.

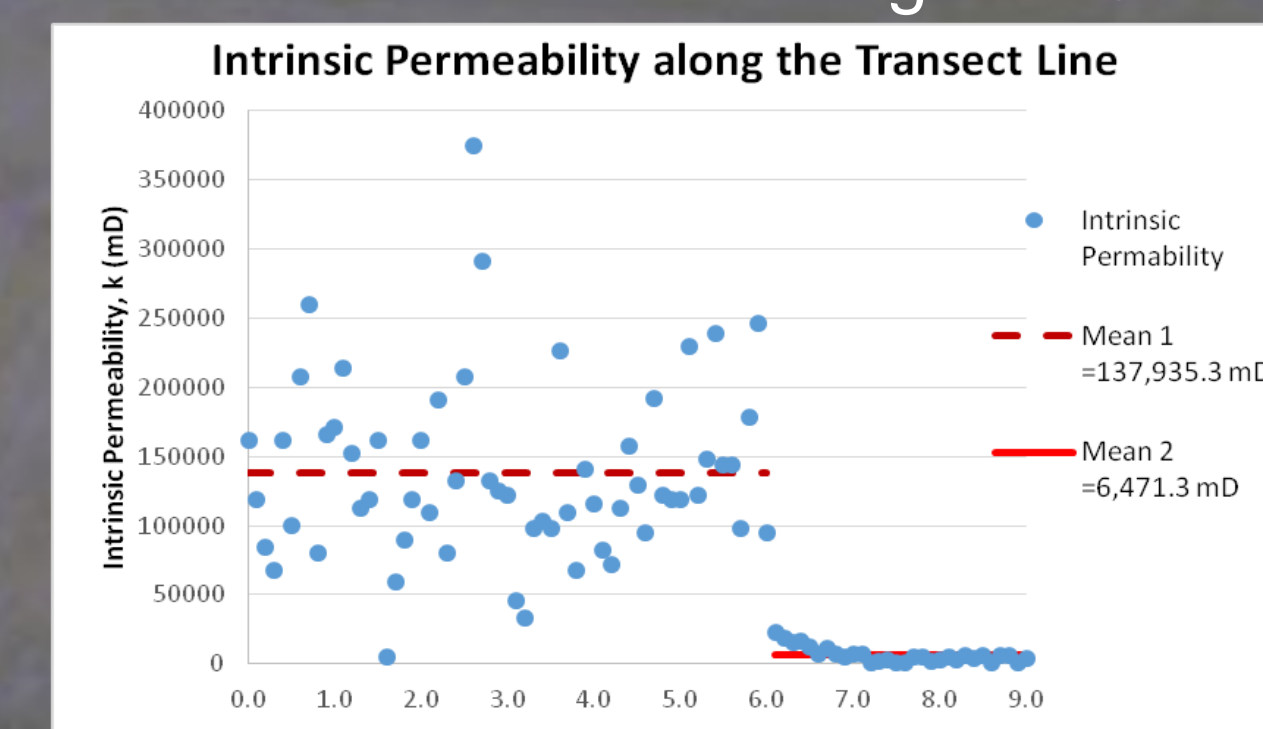
Figure 13: Plot of permeability along the survey line. The mean of the first 6-m zone (fill) is over 21 times higher than that of the last 3-m zone (natural soil).

- ❖ Thermal Infrared cameras (i.e., FLIR S40 and T620) successfully detected the different thermal regime above a water track (Figure 12).
- ❖ Intrinsic permeability characterization along a transect line through a water track revealed contrasting difference in the permeability of the natural soil and the foundation fill. Refer to Figure 13 below.
