Large Wood Project Objectives and Layout

North Fork White River Watershed Site Characteristics

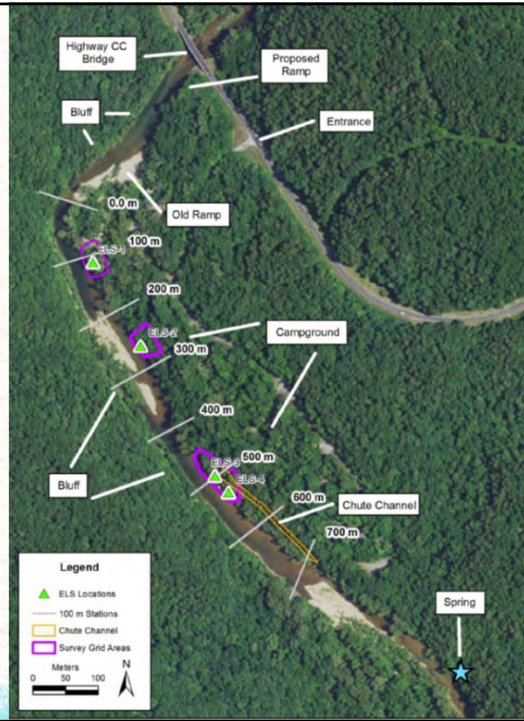
- Mitigate / control sediment coming off of recreation area from entering endangered Hellbender habitat immediately downstream
- Mitigate bank toe and slope erosion
- Buffer bank toe from floods
- Demonstrate large wood structures can be effective and remain in Missouri rivers

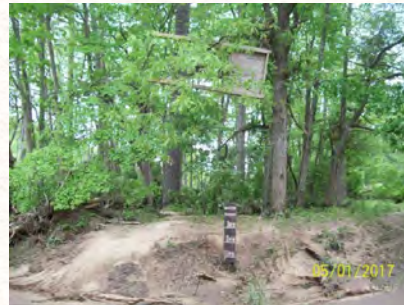
- Basin Area = 403 Square Miles
- Annual Precipitation = 47"
- Bankfull Width =
 - Min. 128.5 Feet
 - Ave. 167 Feet
 - Max. 241 Feet

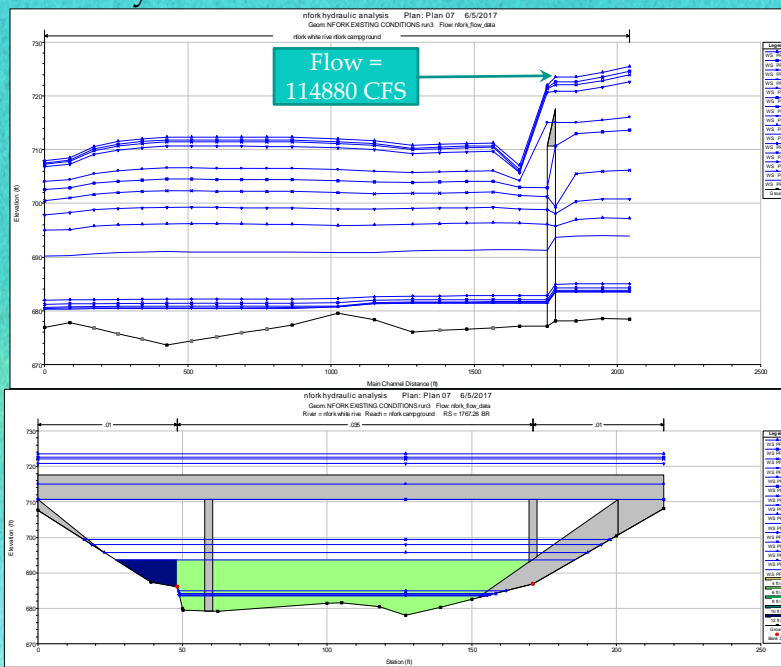
Hydraulic Analysis Results

Bridge cross section is truncated.

Elevation of the Q500 approximately coincides with the highest debris line ~46 ft by the Bridge. Flow Return interval will be greater than Q500!

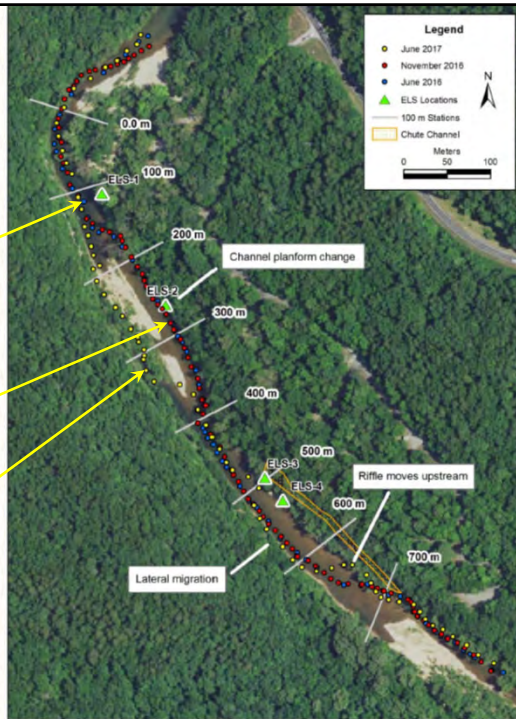
Channel Thalweg Position Changes

- Pre-project
June 2016
Blue Dots
- Thalweg at time of construction
Nov. 2016
Red Dots
- Post flood
June 2017
Yellow Dots

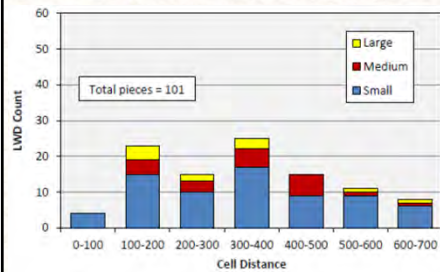
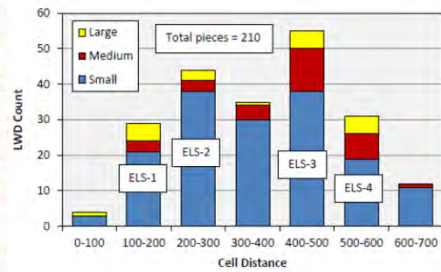
Wood Loading in Study Reach

Study Reach Length = 700 meters long
Wood counted had to be 0.1 meter in Diameter

- Small Wood = <0.3 m
- Medium Wood = >0.3 m and <10 m long
- Large Wood = >0.3 m and >10 m long

- 101 LWD pieces – 4 to 25 pieces per 100 meters

- 210 LWD Pieces – 4 to 55 pieces per 100 meters

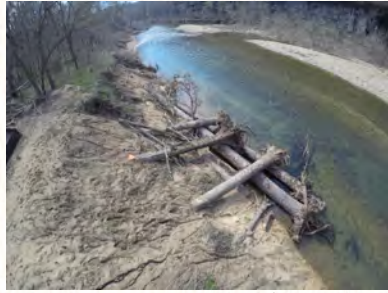
Nov. 2016 – As-Built

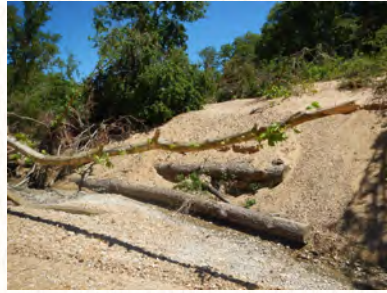
June 2017 – Post Flood

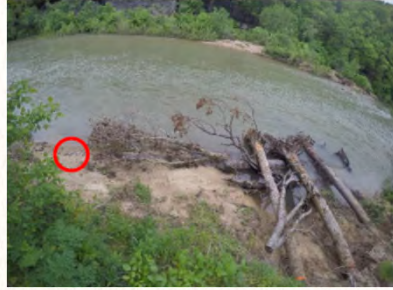
April 2017 – After 2 Bankfull flows

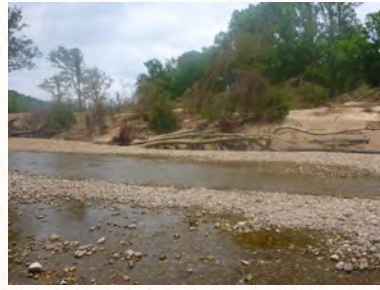
June 2017 – Post Flood

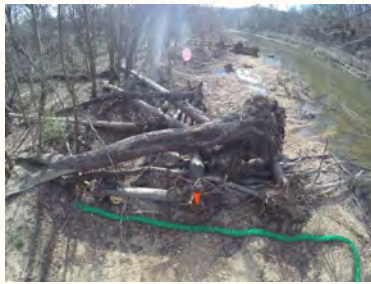
Nov. 2016 – As-Built

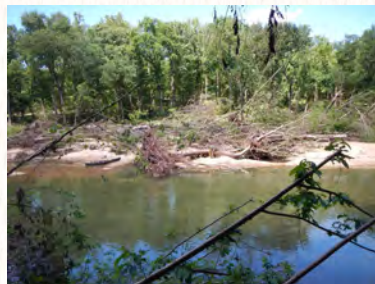
June 2017 – Post Flood

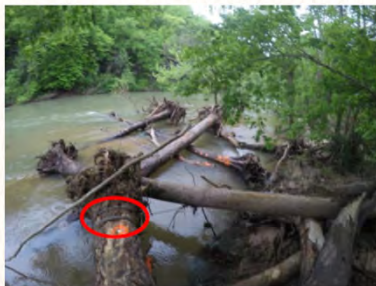
April 2017 – After 2 Bankfull flows

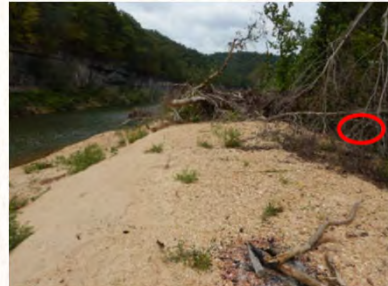
June 2017 – Post Flood

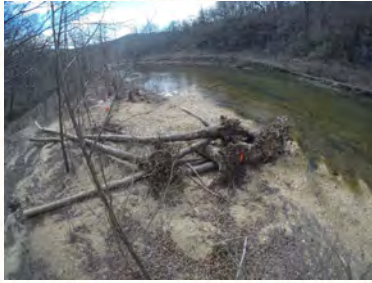
Nov. 2016 – As-Built

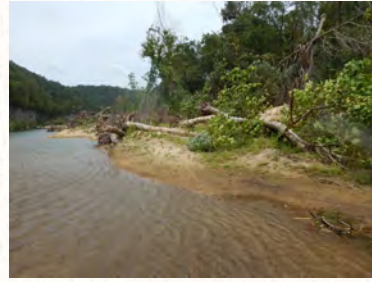
June 2017 – Post Flood

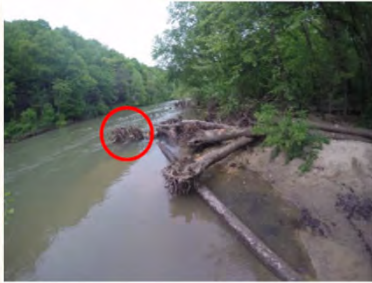
April 2017 – After 2 Bankfull flows

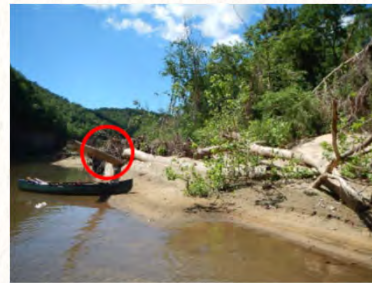
June 2017 – Post Flood
