USDA Forest Service  
Watershed Restoration  
Enterprise Program

Layout, logistics,  
limitations, equipment  
types and timing

Brian Bair,  
Watershed Restoration Projects Lead,  
USDA Forest Service  
Washington Office  
Enterprise Program

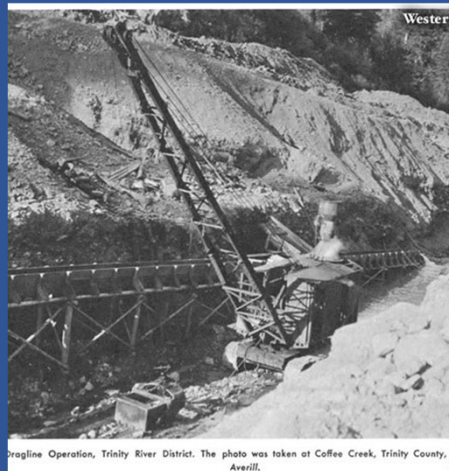
Dragline Operation, Trinity River District. The photo was taken at Coffee Creek, Trinity County, in 1940. Photo courtesy of Western Consolidated Industries.

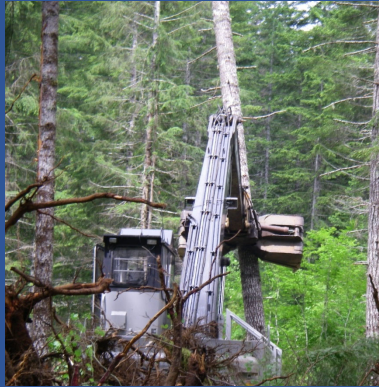
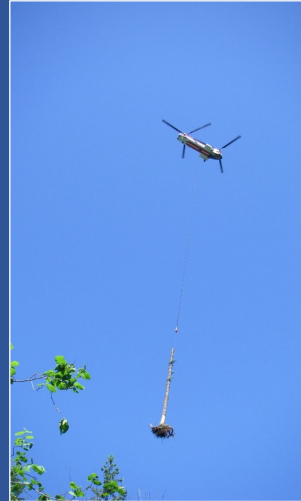
## SF Skokomish Rehabilitation Project

2150 trees from second growth timber units were pushed over and transported for the project

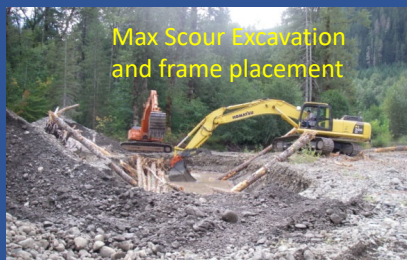
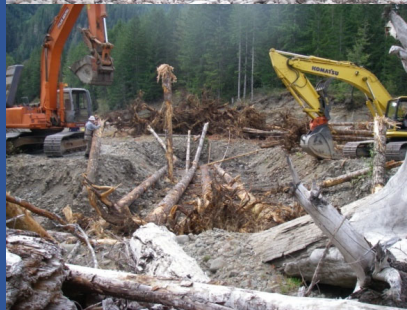
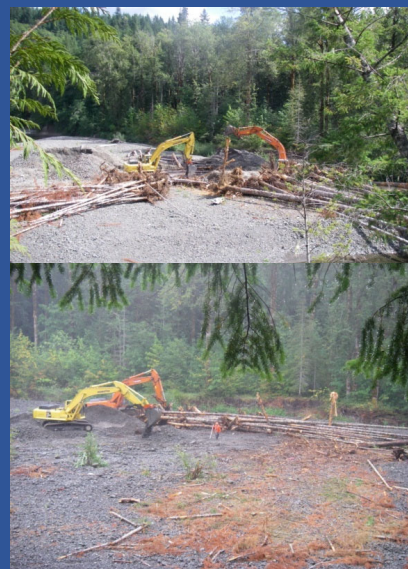
Because this is a big river ~6,000-8,000 cfs bankfull...(flood prone widths >600m) the floodplain and gravel bar structures were critical and needed to work in concert with the FMFs.

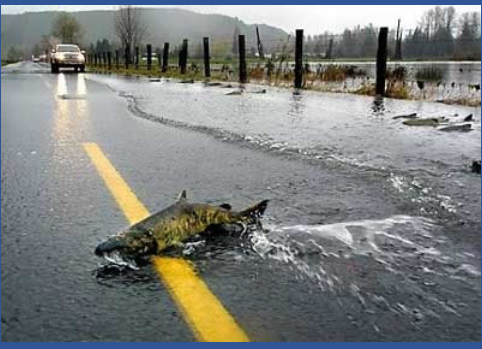
Restoration Law 1.0  
 After implementation of any stream restoration project, thou shalt be smythed with big water.  
 16,800 cfs 9<sup>th</sup> highest on record

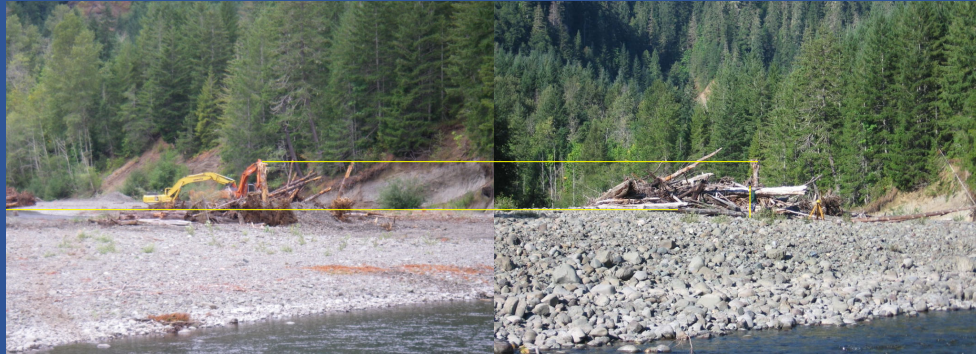
On average gravel bar heights increased 2.4 feet through the project reach.

Max accumulation height was 6.6 feet

- Gravel bars increased 2.4 feet on average throughout the project area
- The thalweg decreased on average -2.0 feet.
- Estimated sediment storage volume accumulated by the bar structures (bar deposition - thalweg scour) is 43,000 yd<sup>3</sup> or 9yd<sup>3</sup> for every linear foot of stream. So instead of producing 8,000 cy/year the project area is now storing
- As a consequence of the bar deposition and thalweg scour the channel forming ~ bankfull width / depth ratios decreased 49% and low flow w/d decreased 36%
- Pools greater than 5' residual pool depth doubled from 3 to 6 within the project reach.
- As far as durability goes this years flow was the 9th highest on record and we did not loose a stick. We did accumulate a lot of wood and even snagged an old growth tree.
